**Flood Control Project Maintenance
Levee Inspections**

Fall 2011 Levee Maintenance Deficiency Summary Report

Sacramento River Basin

Reclamation District No. 0787 Fair

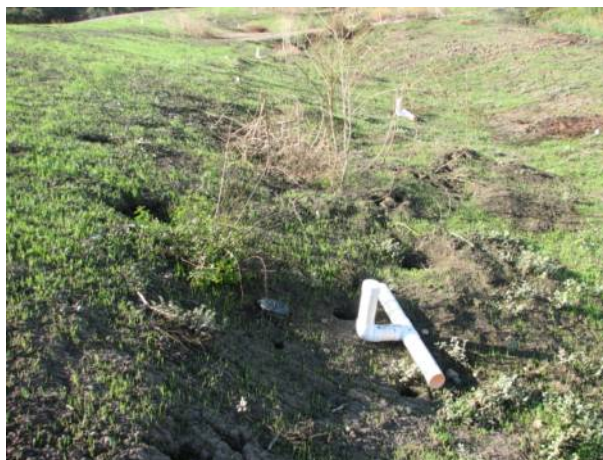
Levee Mile Report Line	1
Start Levee Mile	0.16
End Levee Mile	0.16
Location	Land Side
Category	Earthen Levee
Item	Animal Control

There are multiplable rodent holes in the area. A bait program is in place.

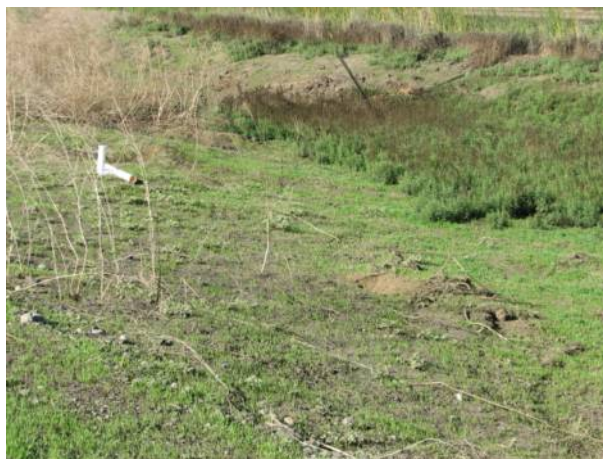
Levee Mile Report Line	2
Start Levee Mile	0.22
End Levee Mile	0.22
Location	Land Side
Category	Earthen Levee
Item	Animal Control

Rodent holes near the bottom of the the levee slope.

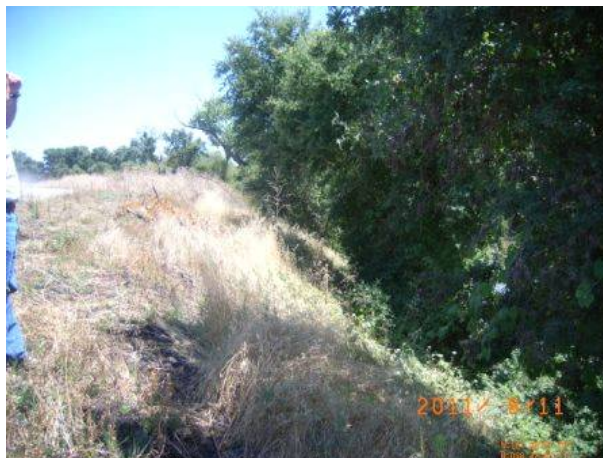
Levee Mile Report Line	3
Start Levee Mile	0.30
End Levee Mile	0.30
Location	Water Side
Category	Supplemental
Item	USACE Erosion Survey

USACE 2011 Photo #1

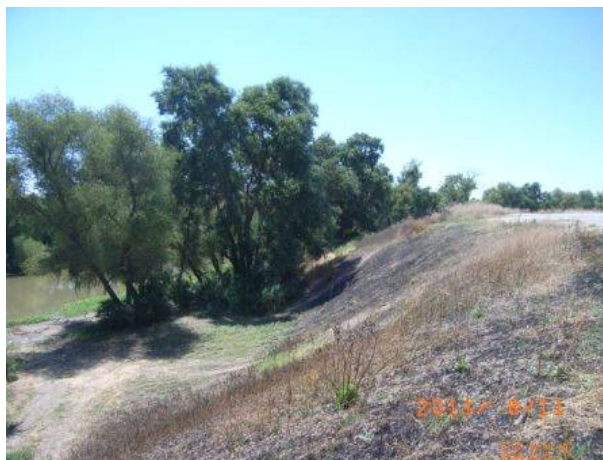
Levee Mile Report Line	3
Start Levee Mile	0.30
End Levee Mile	0.30
Location	Water Side
Category	Supplemental
Item	USACE Erosion Survey

USACE 2011 Photo #2

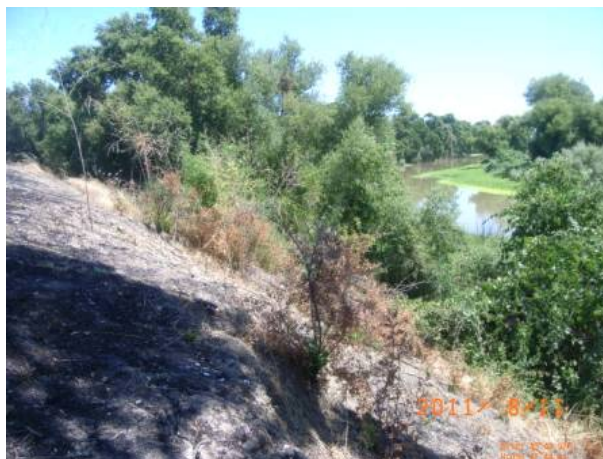
Levee Mile Report Line	3
Start Levee Mile	0.30
End Levee Mile	0.30
Location	Water Side
Category	Supplemental
Item	USACE Erosion Survey

USACE 2011 Photo #3

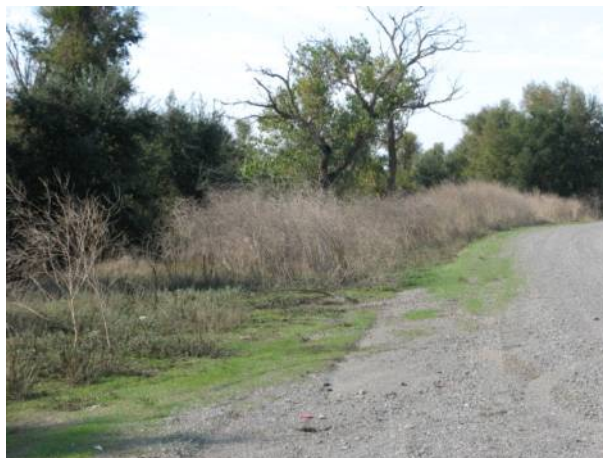
Levee Mile Report Line	4
Start Levee Mile	0.45
End Levee Mile	0.45
Location	Water Side
Category	Earthen Levee
Item	Vegetation

The vegetation is taller than 12 inches tall.

4	0.45	0.45	Earthen Levee	Vegetation	WS	M	Remove the wild growth other than native grasses from the levee slopes.	38.795528 ° -121.731645 °	38.795528 ° -121.731645 °	108 Y
5	0.58	0.58	Supplemental	USACE Erosion Survey	WS	M	Inspector Comments: 2011: Large scallops throughout the entire reach. Toe scour due to tree pop-outs, resulting in a steepening slope. The reduced resistive forces plus clay levee may increase the loading. [2011 Site ID: CBD_0-9_L]	38.795486 ° -121.735647 °	38.796225 ° -121.738902 °	2 Y
6	1.09	1.13	Earthen Levee	Vegetation	WS	M	Remove the wild growth other than native grasses from the levee slopes.	38.797887 ° -121.742839 °	38.798257 ° -121.743356 °	109 Y
7	1.57	2.71	Earthen Levee	Encroachments	LS	PO	Agricultural Ditch	38.801794 ° -121.750204 °	38.809506 ° -121.768979 °	13 Y
8	3.11	4.37	Earthen Levee	Encroachments	LS	PO	Agricultural Ditch	38.812963 ° -121.774880 °	38.822302 ° -121.795295 °	14 Y

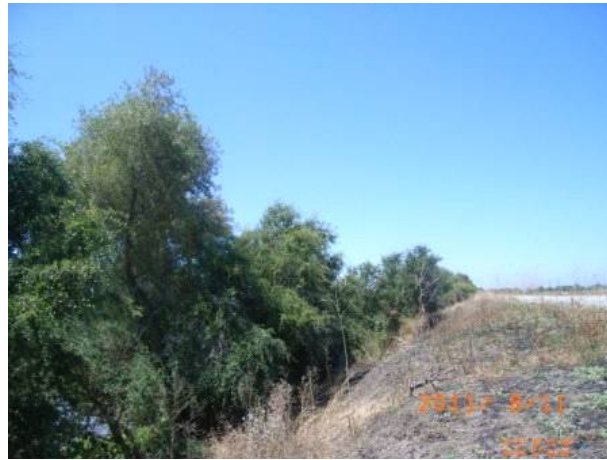
Levee Mile Report Line	5
Start Levee Mile	0.58
End Levee Mile	0.58
Location	Water Side
Category	Supplemental
Item	USACE Erosion Survey

USACE 2011 Photo #1

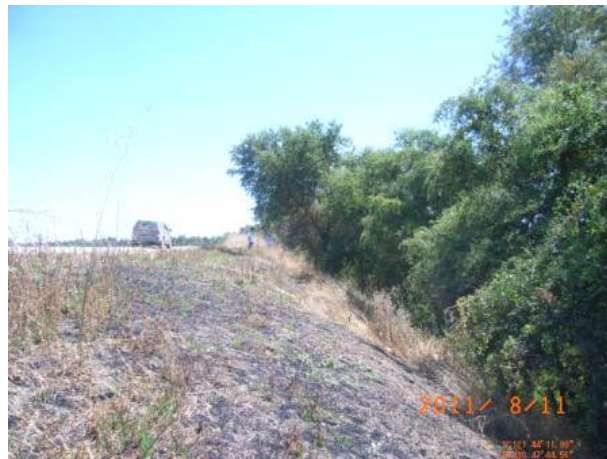
Levee Mile Report Line	5
Start Levee Mile	0.58
End Levee Mile	0.58
Location	Water Side
Category	Supplemental
Item	USACE Erosion Survey

USACE 2011 Photo #2

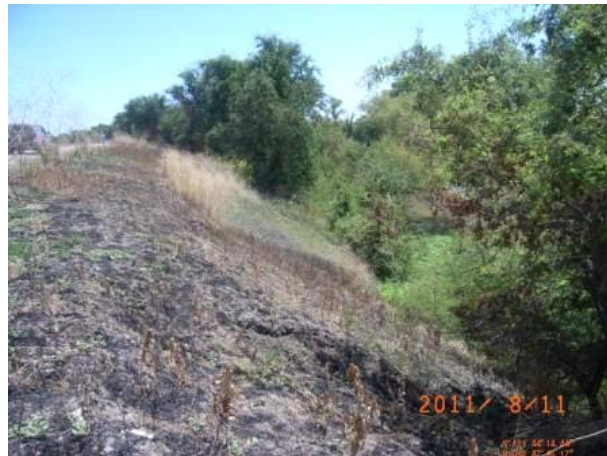
Levee Mile Report Line	5
Start Levee Mile	0.58
End Levee Mile	0.58
Location	Water Side
Category	Supplemental
Item	USACE Erosion Survey

USACE 2011 Photo #3

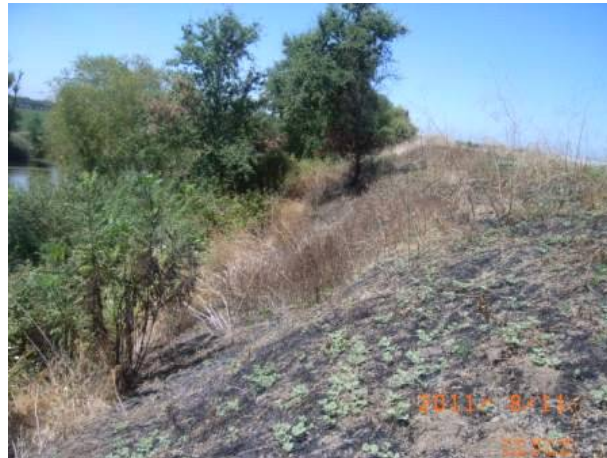
Levee Mile Report Line	5
Start Levee Mile	0.58
End Levee Mile	0.58
Location	Water Side
Category	Supplemental
Item	USACE Erosion Survey

USACE 2011 Photo #4

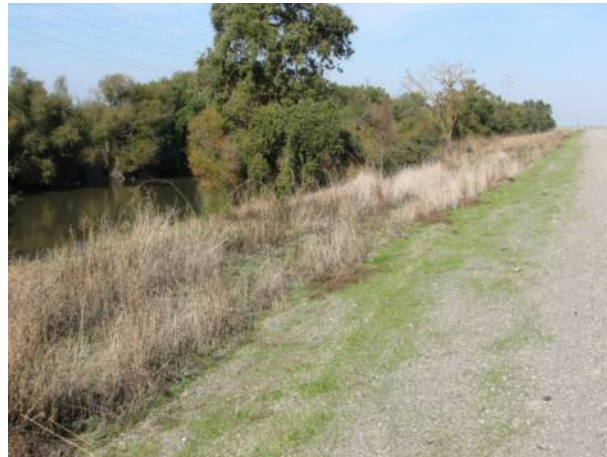
Levee Mile Report Line	6
Start Levee Mile	1.09
End Levee Mile	1.13
Location	Water Side
Category	Earthen Levee
Item	Vegetation

The vegetation is taller than 12 inches.

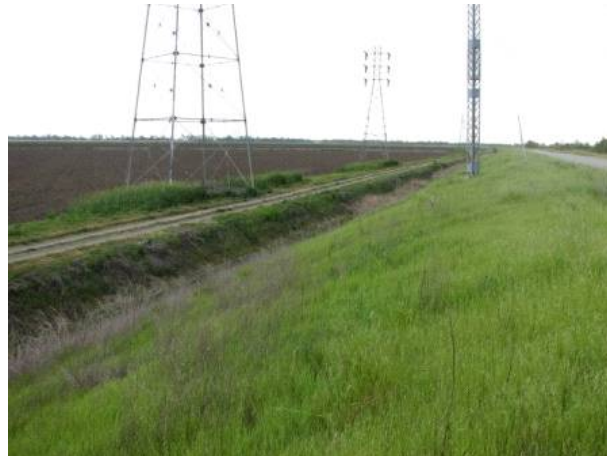
Levee Mile Report Line	7
Start Levee Mile	1.57
End Levee Mile	2.71
Location	Land Side
Category	Earthen Levee
Item	Encroachments

ag. ditch runs along land side the distance of the district

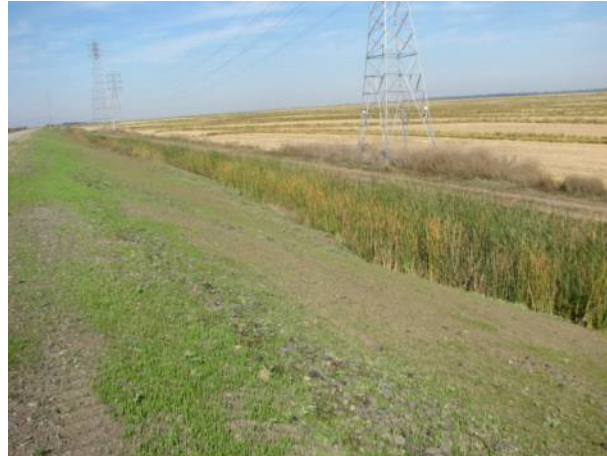
Levee Mile Report Line	7
Start Levee Mile	1.57
End Levee Mile	2.71
Location	Land Side
Category	Earthen Levee
Item	Encroachments

A view of the agricultural ditch in the fall of 2011.

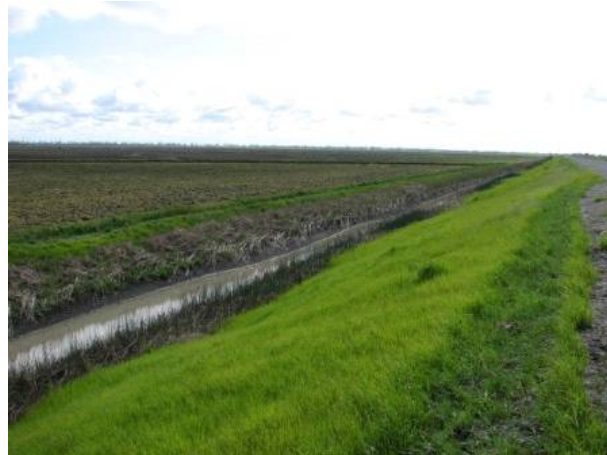
Levee Mile Report Line	8
Start Levee Mile	3.11
End Levee Mile	4.37
Location	Land Side
Category	Earthen Levee
Item	Encroachments

ditch along landside toe

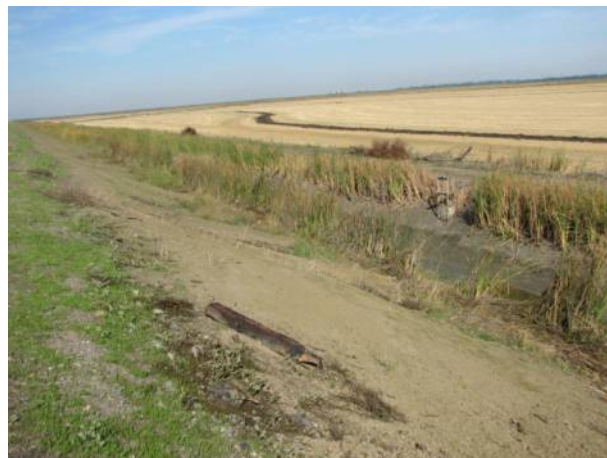
Levee Mile Report Line	8
Start Levee Mile	3.11
End Levee Mile	4.37
Location	Land Side
Category	Earthen Levee
Item	Encroachments

A current view of the agricultural ditch photo taken in fall of 2011.
